# Proposal for the retrofit of the world heritage site of Arge Bam after earthquake damage

J. Motamed & A. M. Alani

*University of Greenwich, Chatham Maritime, Kent, United Kingdom*

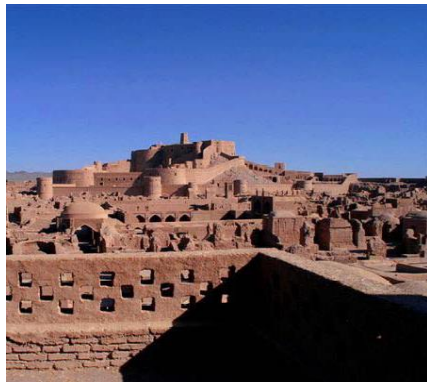
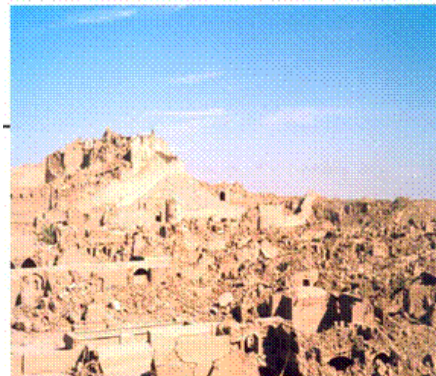
Figure 1. The picture on the left was taken two months before the earthquake of 26 December 2003 (left). The main building of Citadel after 26/12/03 (right).

The historic monument of Arge Bam which is around 220,000 m<sup>2</sup>, includes 25 distinct monuments, comprises residential, social, educational and commercial buildings, a military camp, mosques, bazaar, school, prison, sports centre, ice house, and the governor's section and is surrounded by 2,000 m of walls, Figure 1.

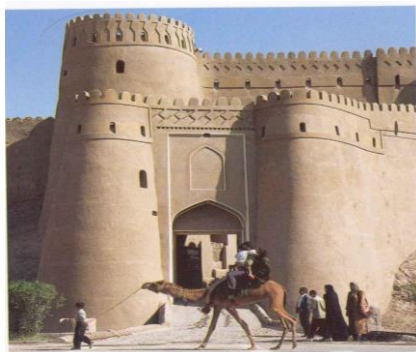
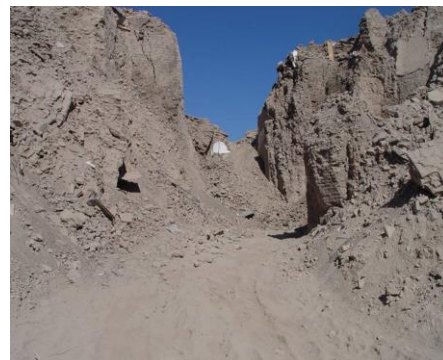
The soil in the lower part of the hill was silt, therefore the monuments located in the southern part of the site, such as the main entrance were more vulnerable to the seismic forces, Figure 2.

The main entrance was coated with heavy clay and lime gypsum render restricting movement joints in the chineh. This rigidity of the rendering resulted in severe compression and external buckling of the earthen walls, Figure 2. In a number of cases the surface rendering separated from the ancient wall in large chunks.

Figure 2. Main chineh entrance to Arge Bam located on the south side of the compound has been restored (left) with mud straw render restricting layered movement joints.

Extensions in later periods during the expansion of the Citadel, and restorations in the second half of the 20<sup>th</sup> century with little architectural and engineering input were the reason behind the scale of destruction of Arge Bam during the earthquake of 2003, Figures 2& 3.

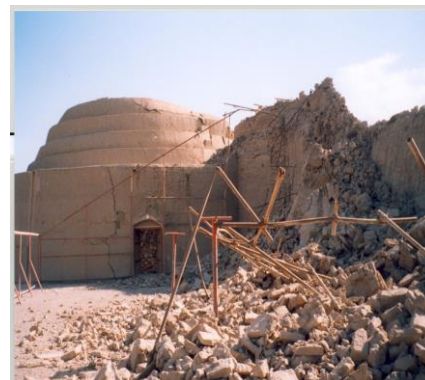
In previous restorations of the Ice House, a stepped dome was built on the existing walls after 1974. The aerial photographs for The National Geographic Magazine in 1974 show that the dome was not reconstructed at the time of that aerial survey (Langenbach 2004). This additional loading

may have resulted in increasing the damage to the inner part of the internal wall as well as initiating vertical structural cracks near its entrance, Figure 3.

Figure 3. The Ice House with the reconstructed dome before (left) and after 26/12/03 (right)
